APOLLO 15 MISSION REPORT

MANNED SPACECRAFT CENTER  
HOUSTON, TEXAS  
DECEMBER 1971

Mission Evaluation Team

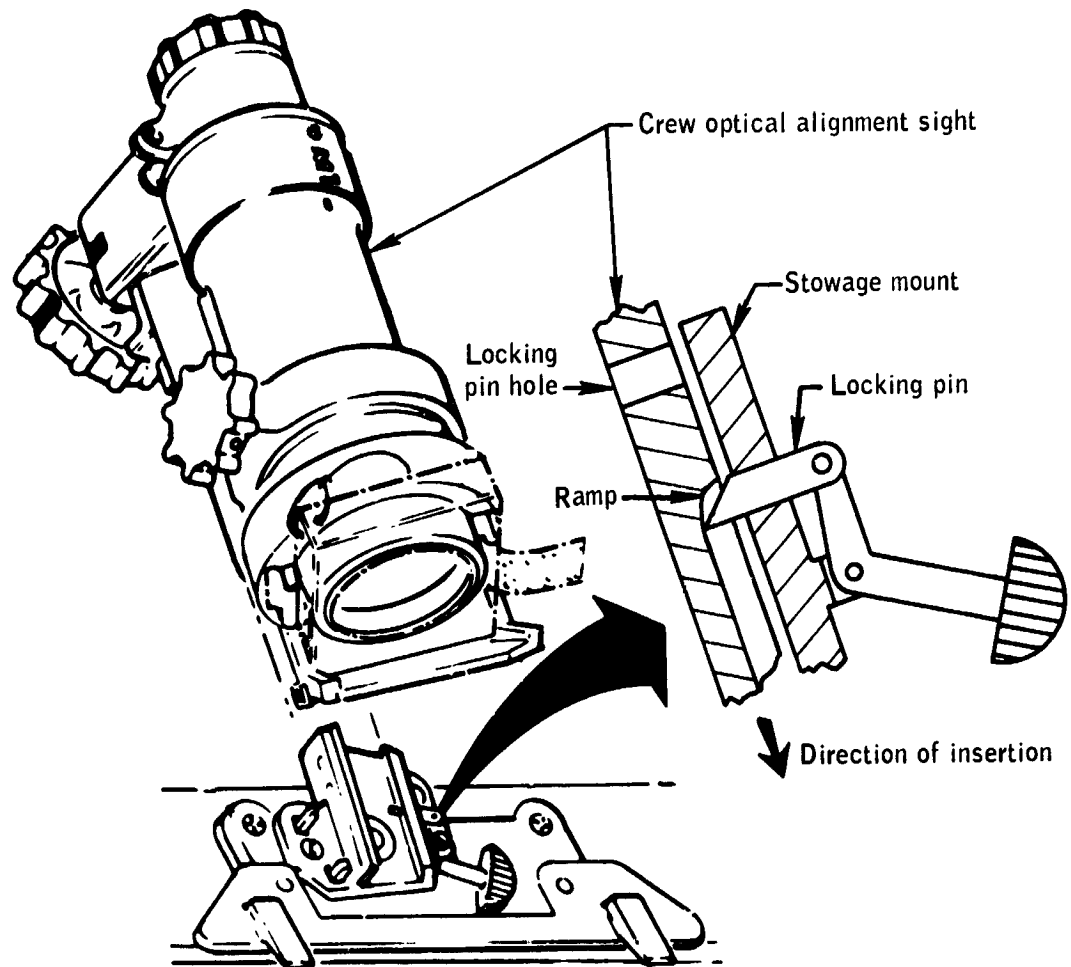
Figure 14-23.- Crew optical alignment sight stowage.

The crew optical alignment sight fell from its stowage mount during landing because the locking pin which secures it was not engaged.

Normally, when the sight is placed into the mount, the locking pin is raised automatically by a ramp and the pin is moved into the locking

pin hole by spring action (fig. 14-23). Postflight examination showed that the ramp had been gouged preventing raising of the pin by the ramp. The cause of the gouge is not known.

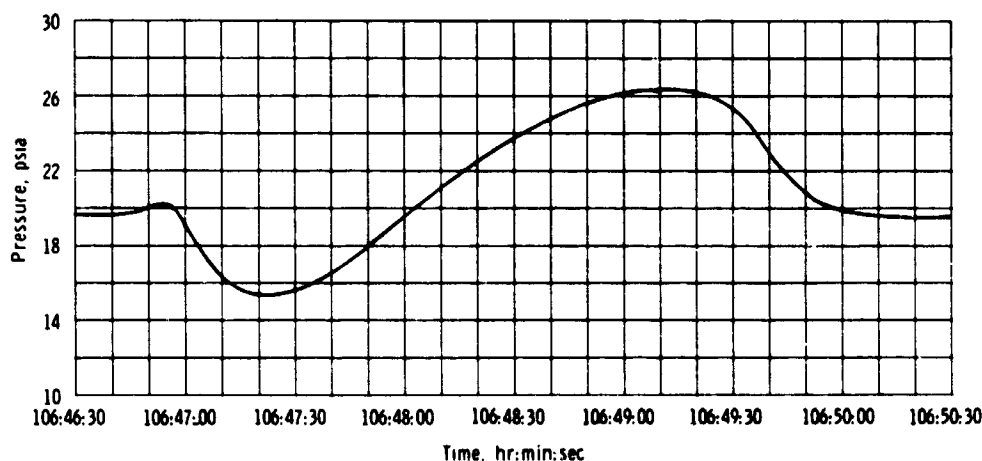
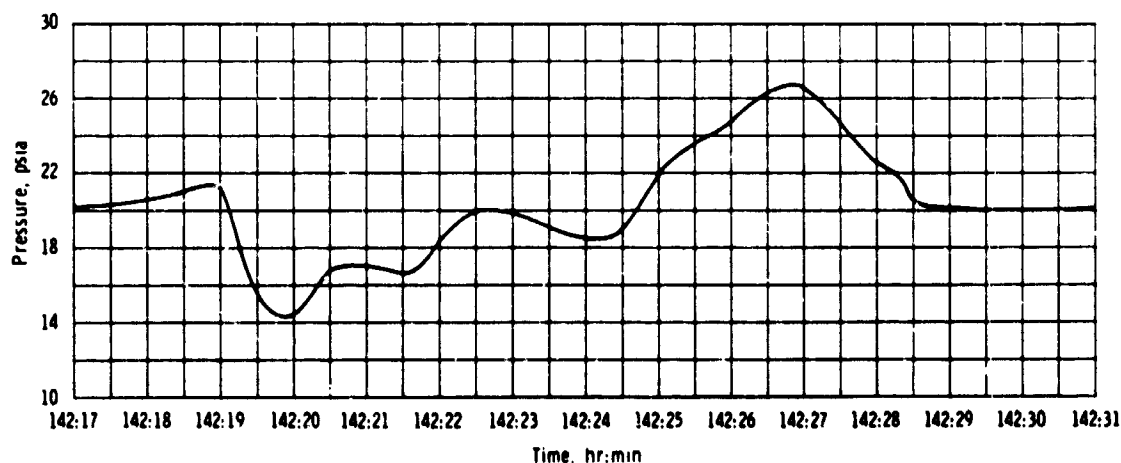
Figure 14-24.- Glycol pump differential pressure variations during extravehicular periods.

Variations were noted in the water/glycol pump differential pressure shortly after the cabin depressurizations for the standup extravehicular activity and the second extravehicular activity. The variations were similar on both occasions. The pressure differential decreased from about 20 psid (normal) to about 15 psid, then increased to about 27 psid and returned to normal (fig. 14-24). The total times for the cycles were 3 minutes during the standup extravehicular activity and 10 minutes during the

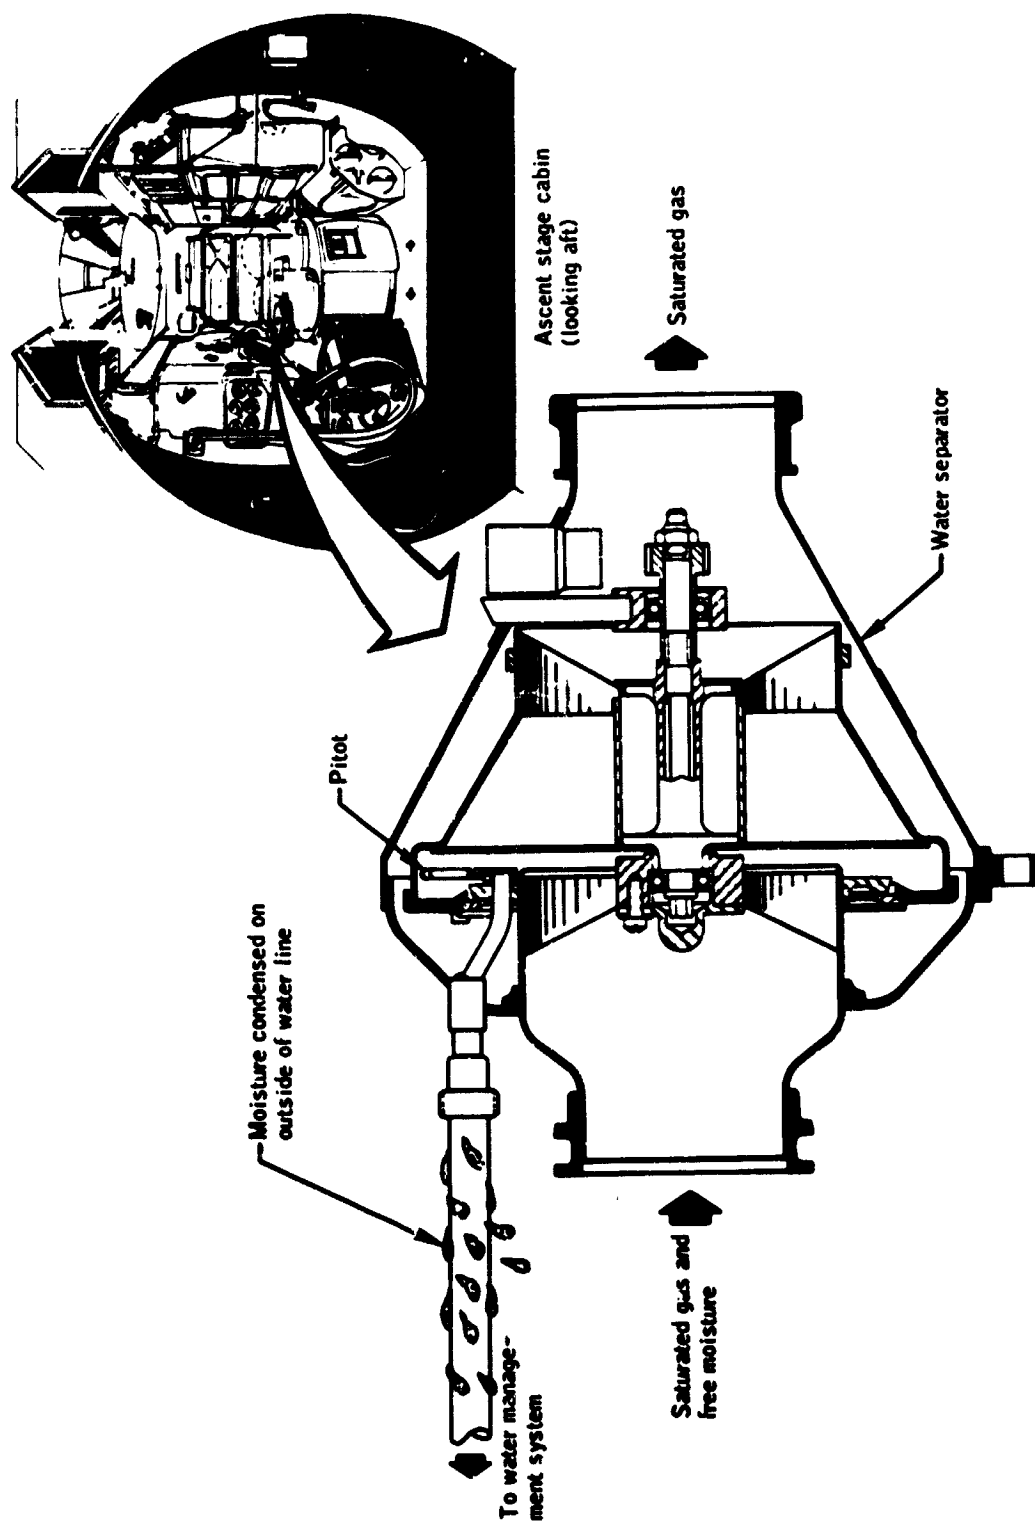
Figure 14-27.- Cross section of water separator.

Cabin atmosphere is cooled and passed through one of the water separators (fig. 14-27) where condensed water is separated by centrifugal force and picked up by a pitot tube. The water is then piped from the pitot tube, through a check valve, to the water management system where it is used the sublimator.

conditions, water would condense on the outside of the line (fig. 14-27), and when the cabin was depressurized for the standup extravehicular activity, the water on the outside of the line would boil, freeze, and sublime, thereby freezing the water in the line.

Analysis shows that as little as a 0.01-inch film of water on the outside of the line will freeze the line at cabin depressurization. Freezing within the line will cause the separator to slow down and stall because of excessive water. Separator 2 had not been used. Therefore, no water was in its outlet line to freeze. Consequently, it operated successfully when activated.

Analysis and tests have shown that freezing of the line will not damage any spacecraft hardware. If such freezing occurs, the other separator would be used. Therefore, no corrective action is required.

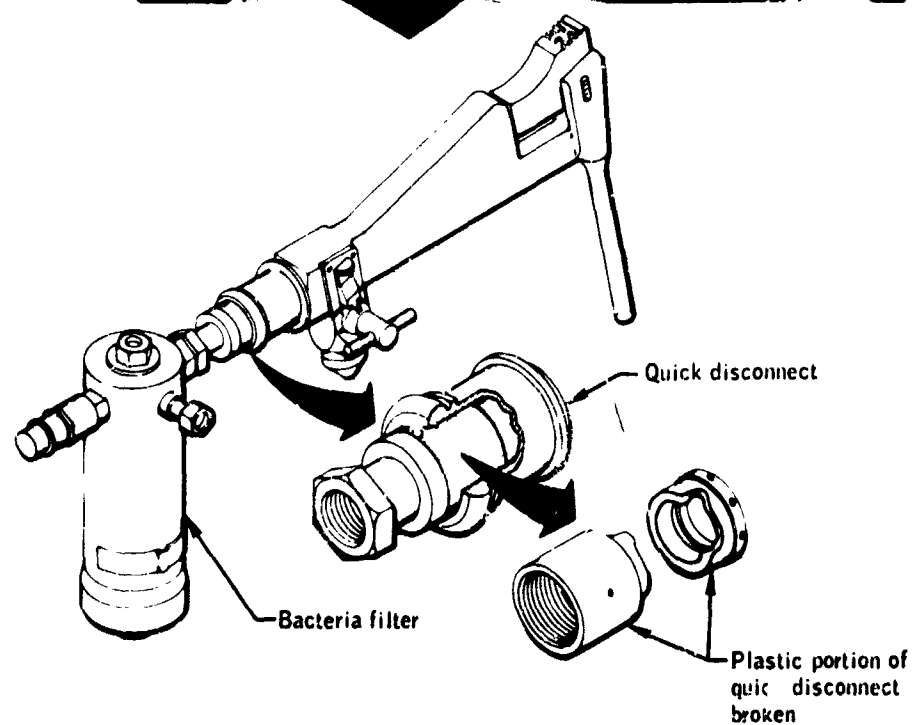
Figure 14-28. - Water gun/bacteria filter.

A water leak occurred at the quick disconnect between the bacteria filter and the water gun (fig. 14-28) shortly after the first extravehicular activity. The leak was caused by the plastic portion of the disconnect being broken and was stopped by removing the filter.

When the water gun/bacteria filter combination is properly stowed, the gun is held in a U-shaped boot (fig. 14-28). Both the gun and filter are held in place by straps with the hose protruding above the liquid cooling assembly. Bending the hose can easily exceed the force required to break the quick disconnect between the bacteria filter and the water gun if the filter is not strapped down. A test showed that a torque of 204.6 inch-pounds caused a similar quick disconnect to break in half.

Based on the torque value of 204.6 inch-pounds, a force of approximately 27 pounds applied at the hose quick disconnect interface would break the disconnect between the filter and the water gun.

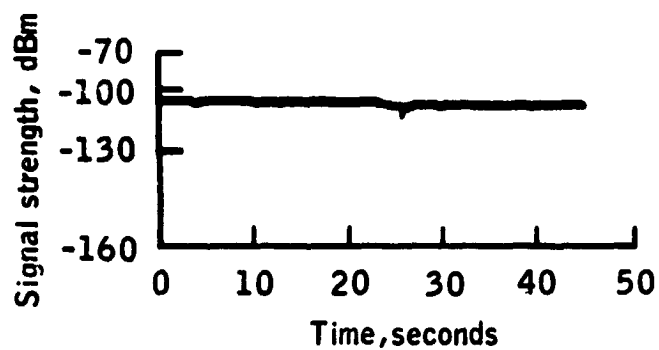
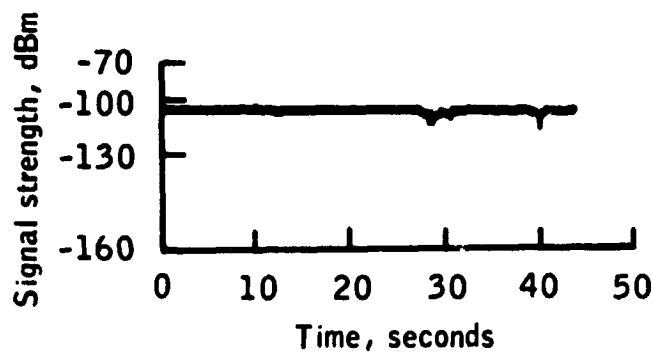
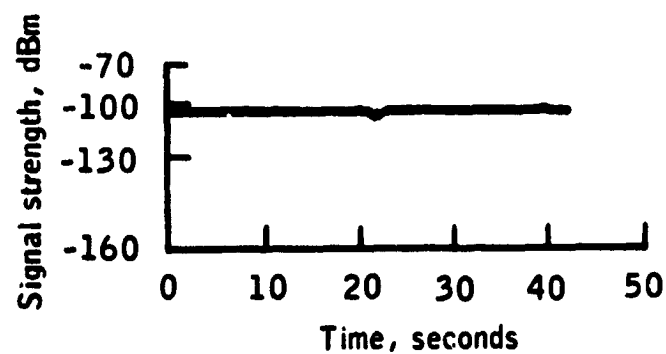
Figure 14-29.- Damped antenna oscillations at random times.

Random oscillations occurred while the steerable antenna was in the auto-track mode. The oscillations were small, and damped without losing auto-track capability (fig. 14-29). The three times when the oscillations became divergent are shown in figure 14-30.

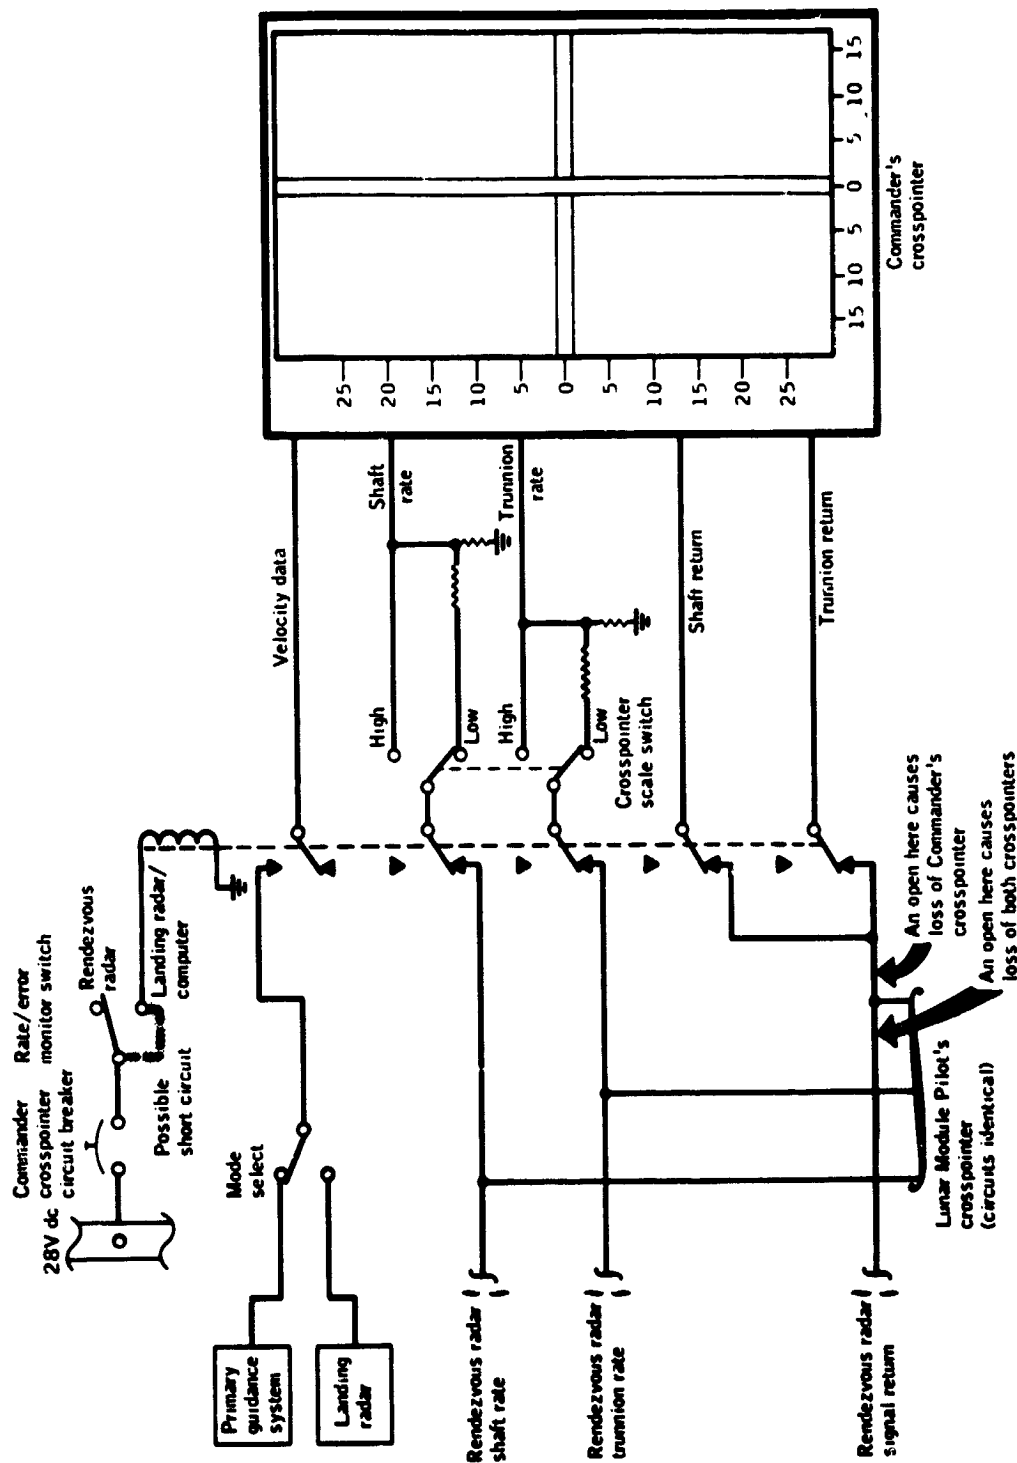
Figure 14-33.- Simplified schematic of crosspointer circuits.

Four possible conditions could have affected the display of radar antenna rate data (fig. 14-33).

- c. An open in the return line would cause loss of rate data to one or both meters, depending upon the location of the open. The signal return lead from the Commander's meter in panel 1 is routed to panel 2 where it is connected to the signal return from the Lunar Module Pilot's meter and routed to the rendezvous radar.

- d. An open in the wire in the rendezvous radar electronics assembly which connects 15 volts at 400 hertz to two velocity filters (one each for shaft and trunnion rate) could cause the loss of shaft and trunnion rate data to both sets of crosspointers.

The most probable failure is an open in the signal return line. Rate information could still be deduced from antenna position data which is displayed on the flight director attitude indicators. Ground tests and checkout may not show this type of failure. If the open is temperature-sensitive, a complete vehicle test involving vacuum, temperature, and temperature gradients would be required to insure that failures of this type would not occur in the flight environment. This type of testing is not practical at the vehicle level. Consequently, no corrective action is planned.

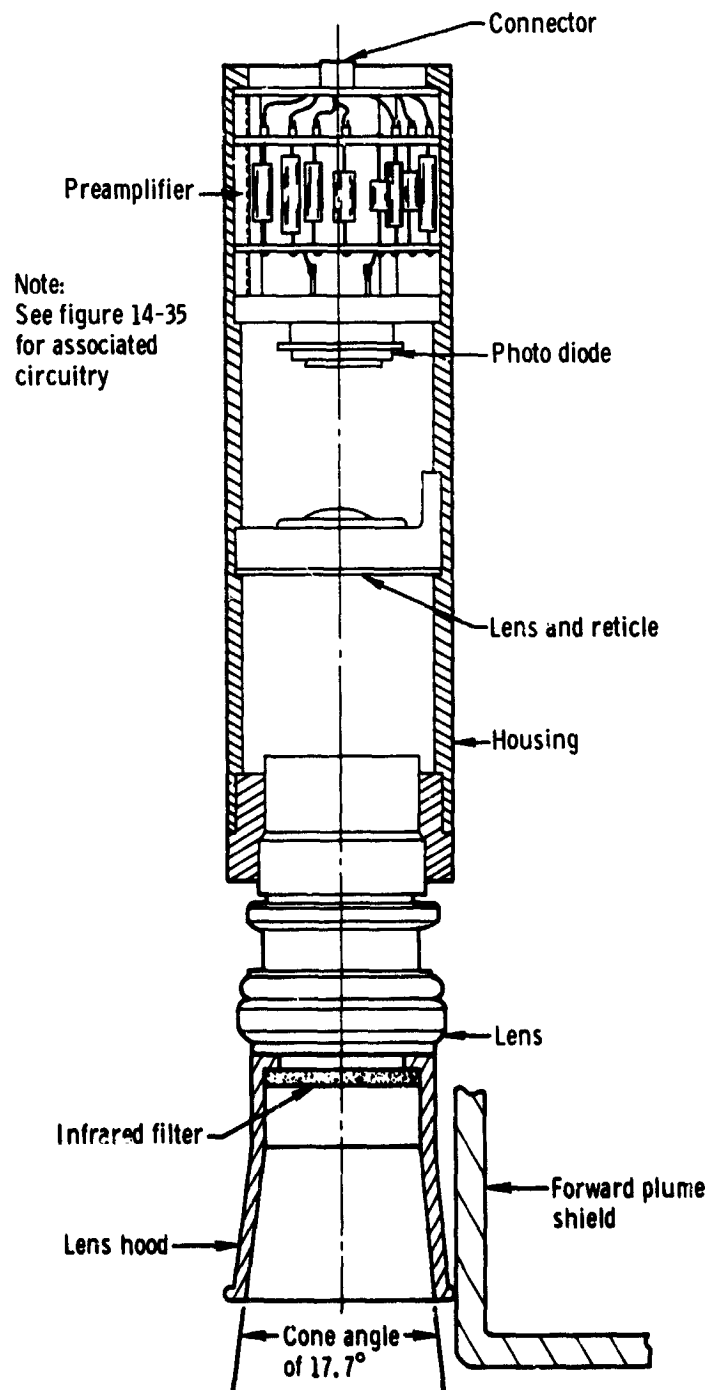
Figure 14-35.- Velocity/altitude sensor assembly.

Telemetry received from the first panoramic camera pass on revolution 4 indicated that the velocity/altitude sensor (fig. 14-35) was not operating correctly.

The velocity/altitude sensor measures the angular rate of travel of the spacecraft relative to the lunar surface. The sensor output is used to control the cycling rate of the camera, the forward motion compensation, and the exposure. The sensor normally operates in the range of 45 to 80 miles altitude. If, at any time, the indicated velocity/altitude is out of this range, the sensor automatically resets to the nominal value of 60 miles. The sensor operated properly for brief periods of time, but would drift off-scale high (saturate), and then reset to the nominal value corresponding to a 60-mile altitude.

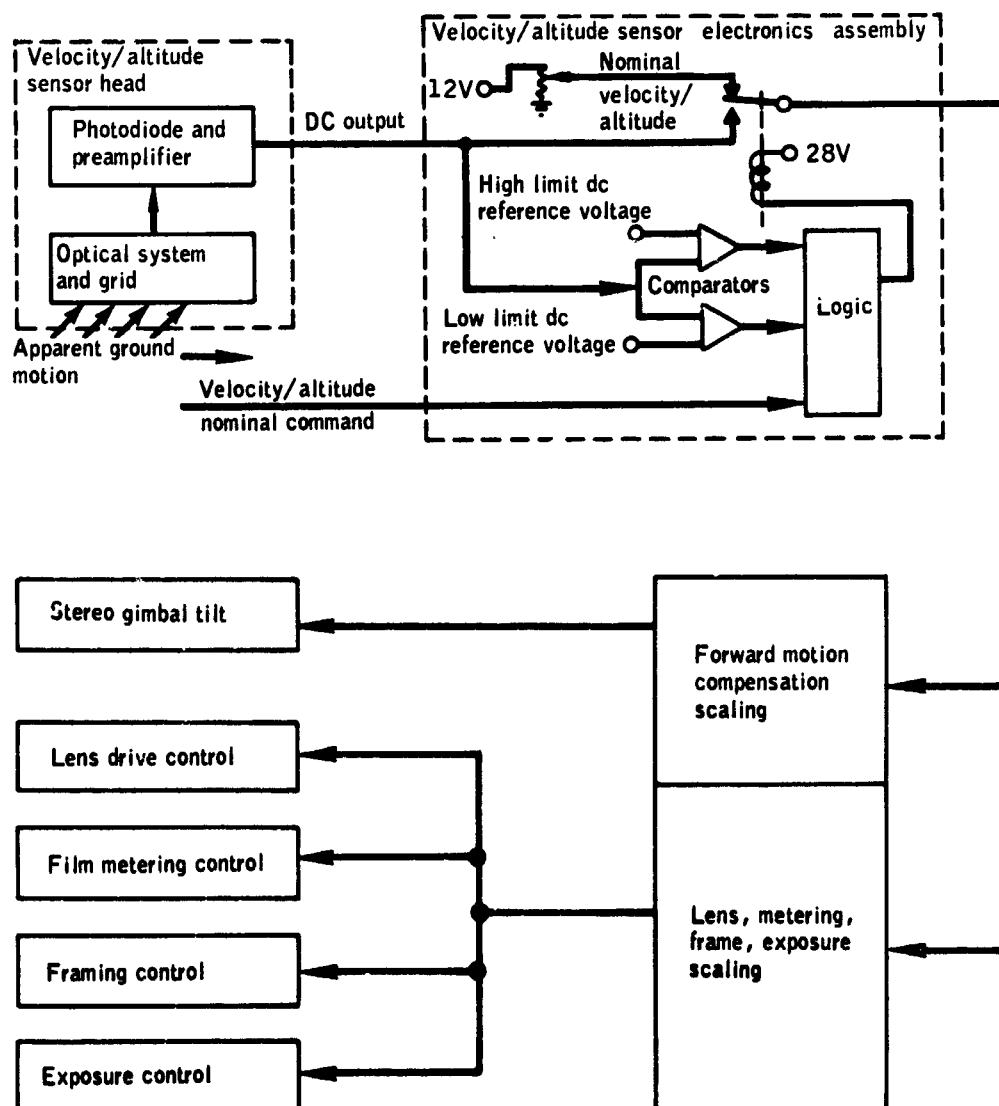
Figure 14-36.- Velocity/altitude output circuitry.

Breadboard tests and circuit analyses of the velocity/altitude electronics (fig. 14-36) did not indicate failure. Tests were conducted in which endless belts of lunar scene photography from Apollo 8 and 15 were passed in front of velocity/altitude sensors. Sensors from the prototype and qualification units, and flight unit number 1 were used. By varying the illumination level, sensor performance somewhat similar to the Apollo 15 anomaly could be obtained.

The results of the tests, coupled with analyses of the basic sensor design, indicate that the problem is related to the optical signal-to-noise ratio. The remaining flight hardware will be modified to improve this ratio. The optical signal will be enhanced by increasing the lens aperture from  $f/4.0$  to  $f/3.5$  and by deleting the infrared filter. The optical noise (reflections) will be reduced by increasing the length of the lens hood and by repositioning the sensor so that the camera's forward plume shield will not be in the field of view of the sensor. In addition, a manual override of the velocity/altitude sensor will be provided on the remaining flight units. By using a three-position switch, two preselected velocity/altitude ratios will be provided, as well as the automatic function.

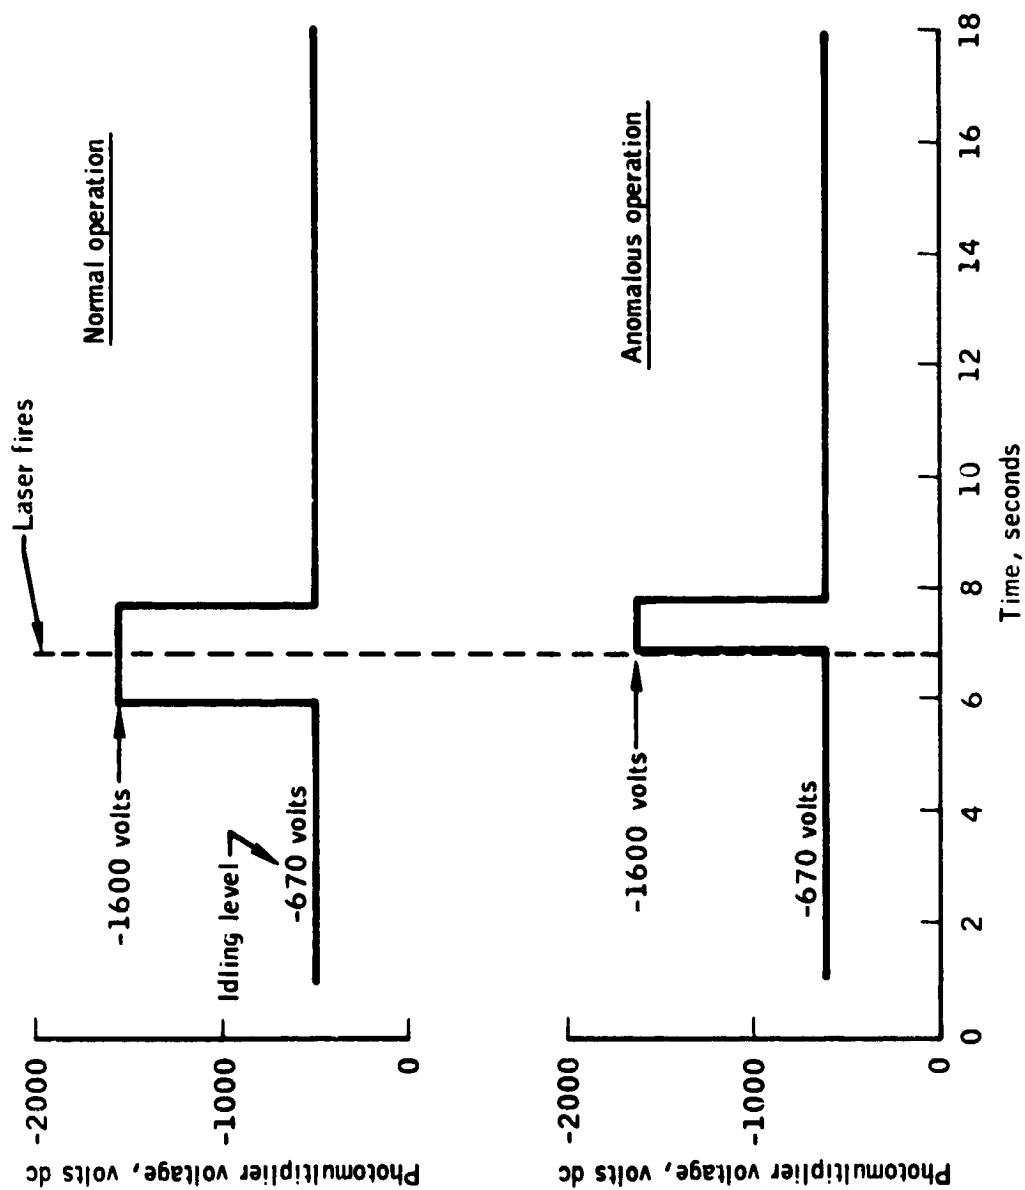
Figure 14-37.- Comparison of photomultiplier power supply voltages.

- a. Altitude data became intermittent after revolution 24 as the result of a decrease in the laser output power.
- b. Beginning with revolution 38, the photomultiplier tube high-voltage power supply was held in the idling (minimum-voltage level) mode until after the laser fired, thereby causing the receiver to miss the return pulse from the lunar surface (fig. 14-37). No altitude data were obtained after this anomaly occurred.

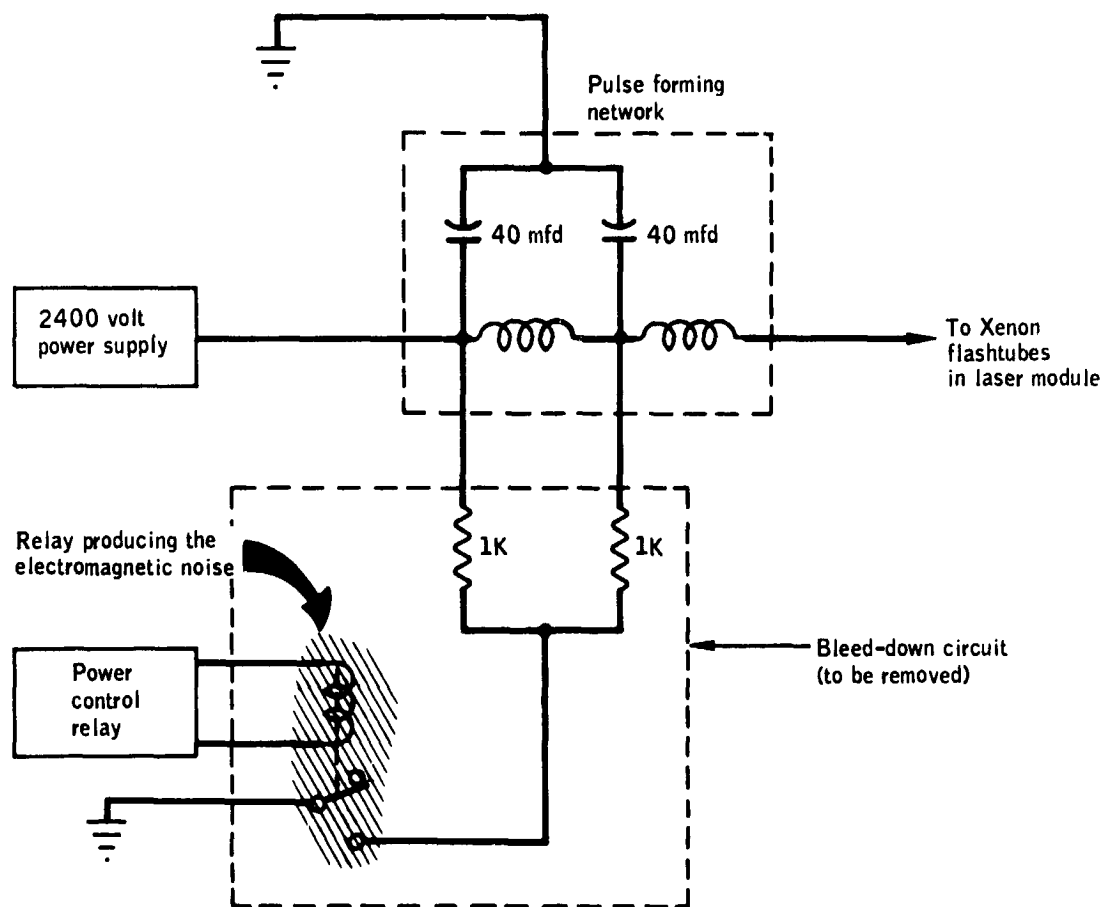
Figure 14-38.- Pulse forming network bleed-down circuit.

The photomultiplier tube power supply anomaly was duplicated when a relay which had been removed from a flight unit because it had an audible "buzz" was installed in the prototype altimeter. The relay serves no function in flight, but is a safety precaution for ground personnel working on the altimeter (fig. 14-38). The relay contacts close when the altimeter is turned off, discharging the high voltage stored in the pulse-forming network capacitors.

It is suspected that the audible "buzz" is accompanied by electromagnetic interference that is coupled into the video amplifier in the laser receiver (fig. 14-39). The video amplifier is a principal element in the automatic gain control circuit which controls the output of the photomultiplier tube power supply. The electromagnetic interference from the relay can thereby result in the automatic gain control holding the power supply in the idling mode until the pulse forming network is discharged in firing the laser. The relay and resistors that comprise the bleed-down circuit will be removed from the remaining flight altimeters.

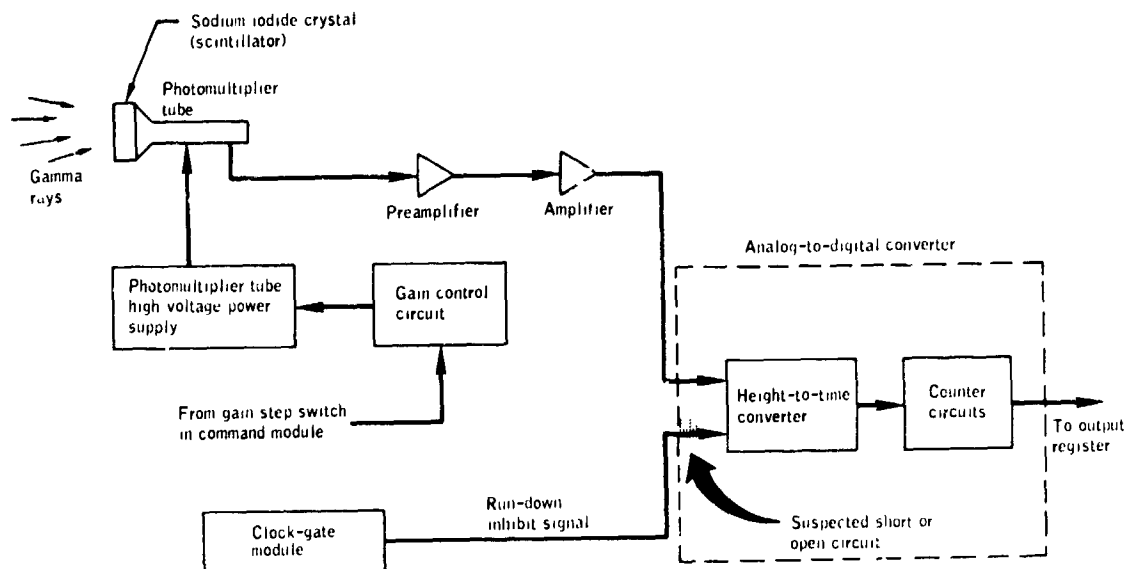
Figure 14-40.- Gamma ray spectrometer circuitry.

During the mission, the gamma ray spectrometer experienced a downward gain shift of approximately 30 percent, but this was compensated for by commanding the high-voltage step function from the command module. The drift decreased with time at an initial rate of 1 percent per hour and a final rate of 0.4 percent per day. Near the end of the mission, the gamma ray spectrometer was operating in a relatively stable state at 824.8 volts (high voltage step 6). (A step 4 voltage of 777.8 volts was the normal position in preflight operation.) The spectrometer to be flown on Apollo 16 was aged at flux rates representative of those encountered in lunar operation. The unit has stabilized after having experienced a gain change of approximately 8 percent.

After transearth injection, a temporary eight-channel zero reference shift was observed. This shift disappeared when the instrument was re-powered after the transearth extravehicular activity, and subsequent instrument operation was normal for about 25 hours during transearth coast. Shortly before entry, the offset shift reappeared and remained until the experiment was turned off. Normalization of the data during processing will compensate for this offset.

Tests conducted with the qualification unit verified that the change in gain was due to aging effects of the photomultiplier tube in the gamma ray detector assembly as a result of high cosmic ray flux rates in lunar operation. The zero shift appears to be associated with the run-down inhibit signal between the clock-gate module and the analog-to-digital converter (fig. 14-40). Absence of this signal at a particular point in the analog-to-digital converter removes a 3-microsecond offset in the pulse height analyzer. The resulting effect is an overall eight-channel offset in the spectrum. The qualification unit was partially disassembled and tests showed that either an open or a shorted wire within the pulse height analyzer can result in an eight-channel offset. An inspection of the circuit in the qualification unit disclosed no design deficiency which would cause this type of failure. Since the eight channel zero offset does not significantly impact overall data quality, no corrective action is contemplated.

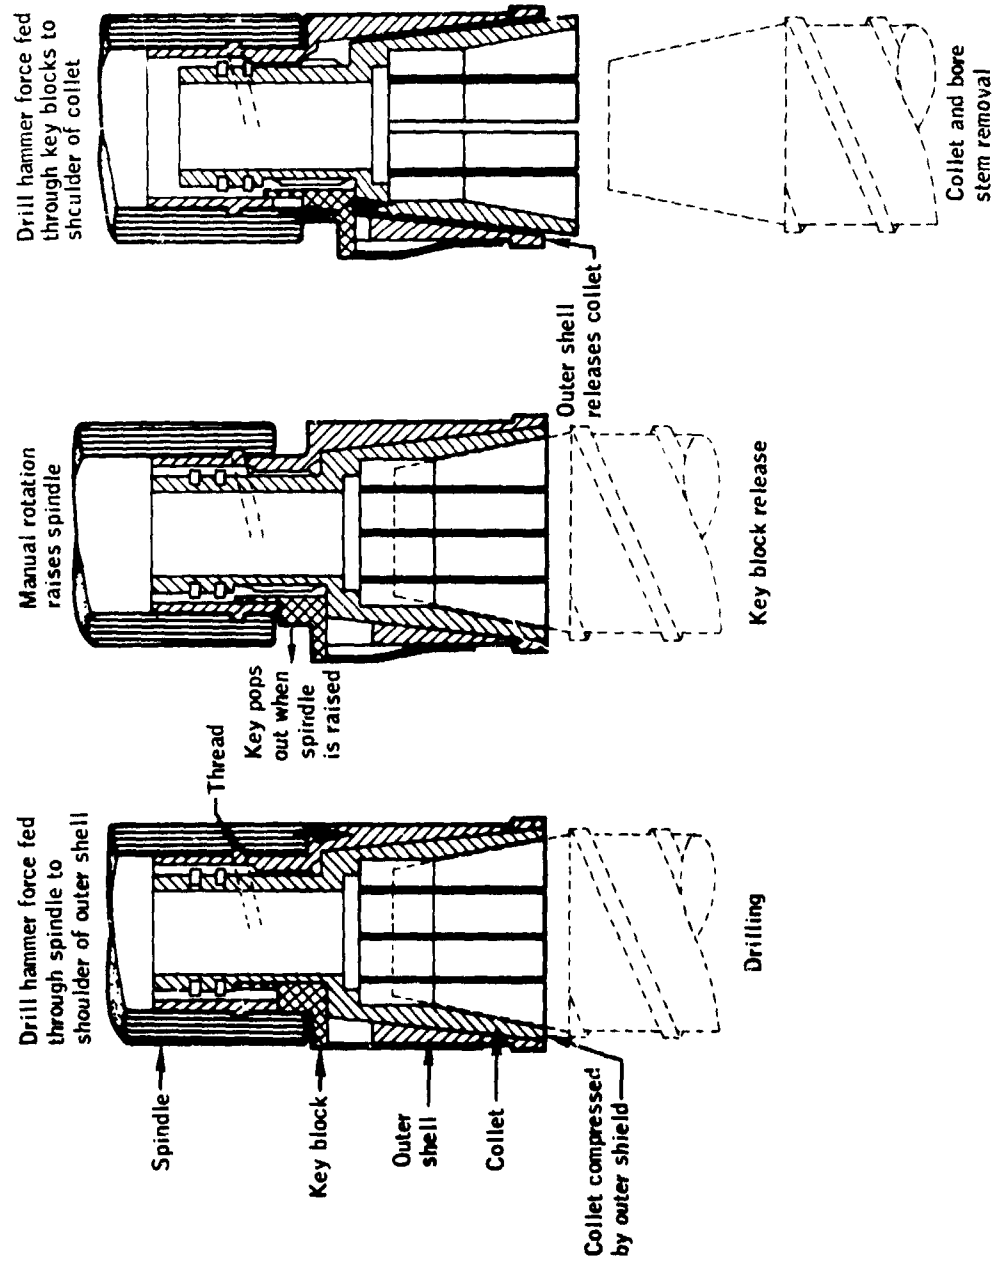
Figure 14-42.- Release of bore stem from drill.

In the bore stem drilling position, the key blocks are restrained inside, and the spindle drives against the shoulder of the adapter outer shell (fig. 14-42). The operational sequence to release the bore stem from the adapter includes the following steps:

In development ground tests, the soil friction usually kept the bore stem from turning in this operation. When there was insufficient friction from the soil, the bore stem was grasped with the gloved hand. On Apollo 15, the soil did not hold the bore stem, and the core-stem wrench was used to hold the bore stems for this operation.

The single-purpose core stem wrench is fitted to the 0.983-inch-diameter titanium core stem, but the 1.088-inch throat will admit the 1.075-inch-diameter bore stem. The softer bore stem (boron-fiberglass laminate) can be deformed and present some difficulty in wrench removal, with possible damage to the bore stem. A wrench to fit both bore and core stems will be provided.

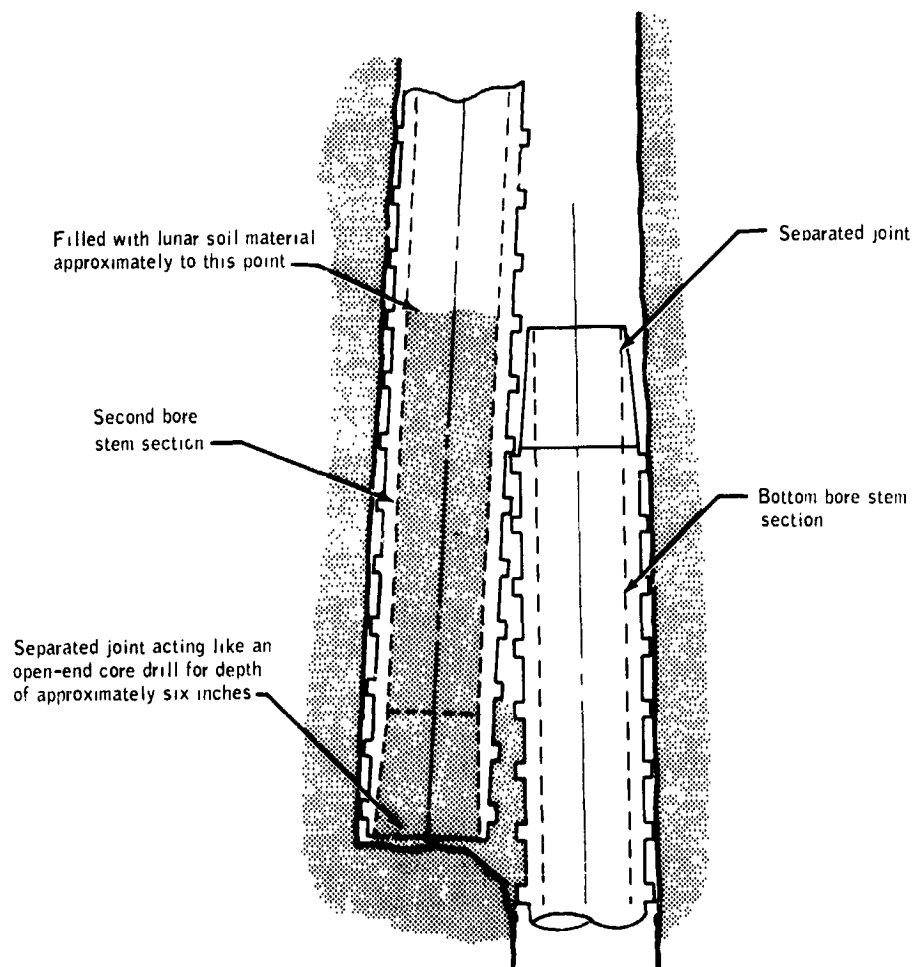
Figure 14-43.- Bore stem joint separation.

14.4.1.3 Bore stem damage near first joint.- The probe would not go to the bottom plug of the bottom bore stem in hole 2, but stopped at a point about 6 inches above the first joint. Examination of photographs and heat flow probe data indicate that, near the end of the bore stem drilling operation, the first joint was separated when the drill and drill string were moved vertically (up and down) in an attempt to improve the drill penetration rate. Easier penetration (for approximately 6 inches) was reported by the crew, but it resulted from the bottom of the second section apparently performing more in a coring manner (fig. 14-43) with the lunar soil entering the second section of the bore stem.

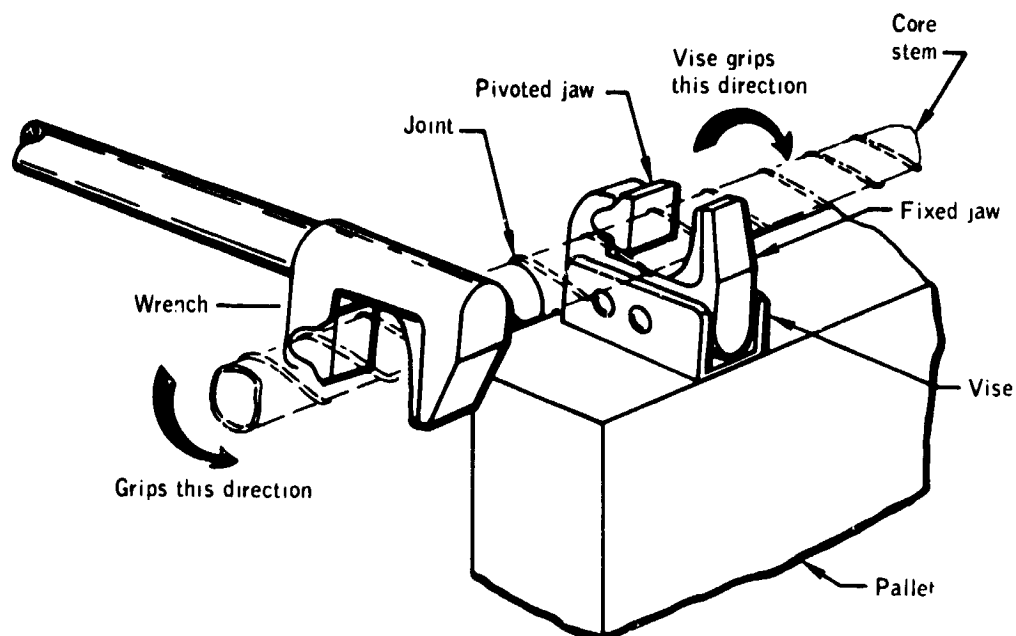
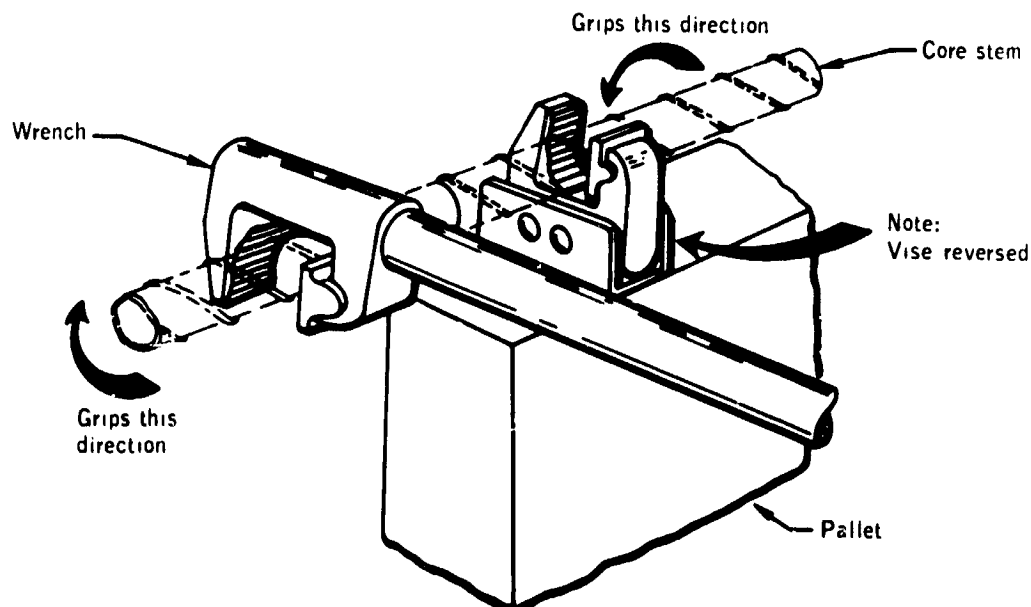
Figure 14-44.- Installation of core stem vise on rover pallet.

As mounted, the vise would hold the core stem so that the joint could be tightened by rotating the wrench on the adjoining section. However, the vise would not hold in the opposite direction so that the joint could be loosened and separated (fig. 14-44). Working on the inboard side of the vise, the core stem could have been held properly for loosening; however, there is insufficient clearance on the inboard side of the vise for wrench rotation, and the distance to the other side of the lunar roving vehicle is greater than the length of a core stem section.

(a) Correct vise installation - will only loosen joint.

(b) Incorrect vise installation - will only tighten joint.

The installation drawing of the vise was in error and has been corrected to assure correct orientation of the vise for Apollo 16. The training vise was installed backward from the erroneous drawing, but correct for loosening the stems.

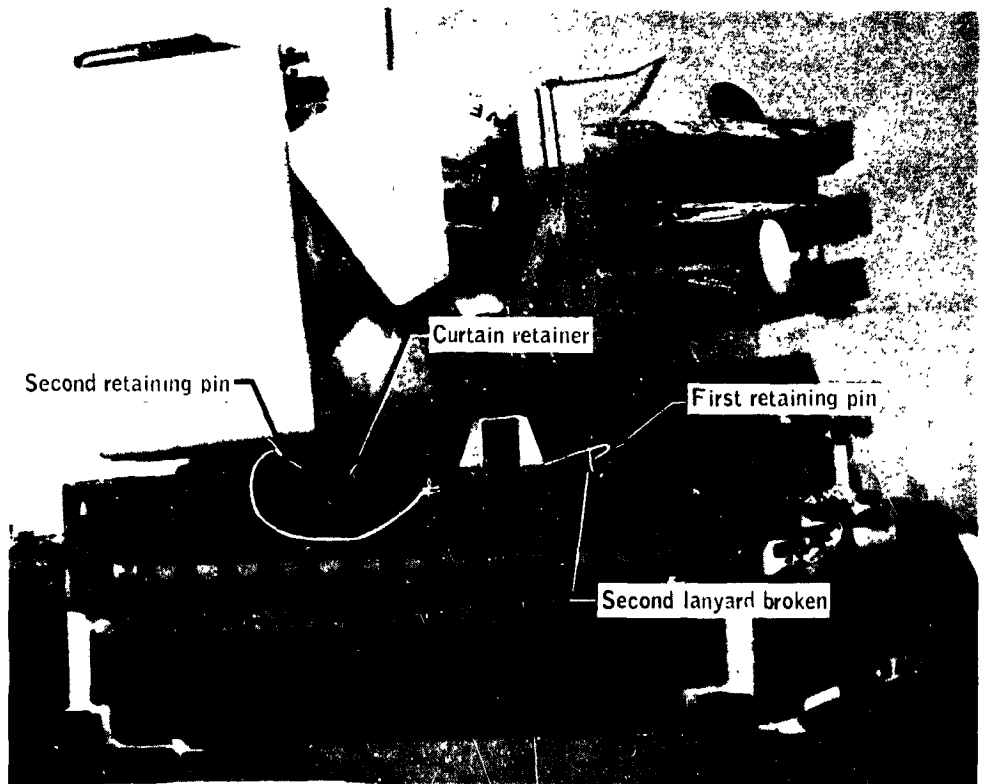
Figure 14-45.- Central station rear curtain retainer removal.

To remove the retainer for the central station rear curtain, added for Apollo 15, it was necessary to remove two retaining pins (fig. 14-45). The two pins, a universal handling tool fitting, and the curtain retainer are joined by a three-section lanyard. When the universal handling tool was inserted in the fitting and raised to remove the first pin, that section of the lanyard broke. When an effort was made to remove both pins simultaneously by inserting the handle under the lanyard joining the two pins, that part of the lanyard broke. The pins and retainer were then removed by hand.

(a) First break of lanyard

(b) Second break of lanyard

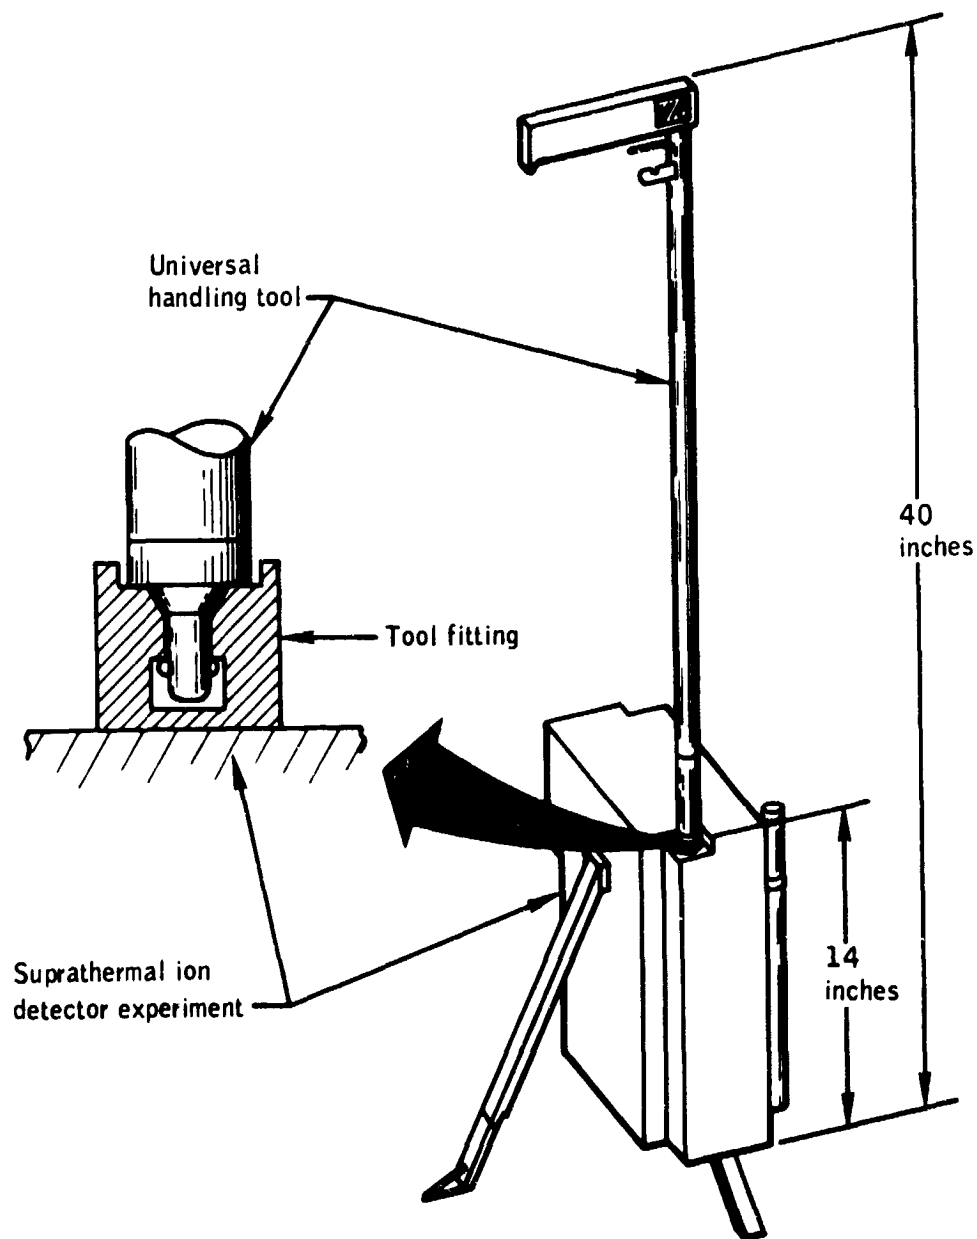
Figure 14-46.- Universal handling tool - suprathermal ion detector experiment interface.

While carrying the suprathermal ion detector experiment from the sub-pallet to the emplacement site, the experiment fell off the universal handling tool at least twice. The experiment sustained no visible damage and has been operating satisfactorily.

The universal handling tool fitting on this experiment is in the highest location above the lunar surface of any of the fittings and presents an awkward position of the tool for insertion, locking, and maintaining lock in the fitting (fig. 14-46).

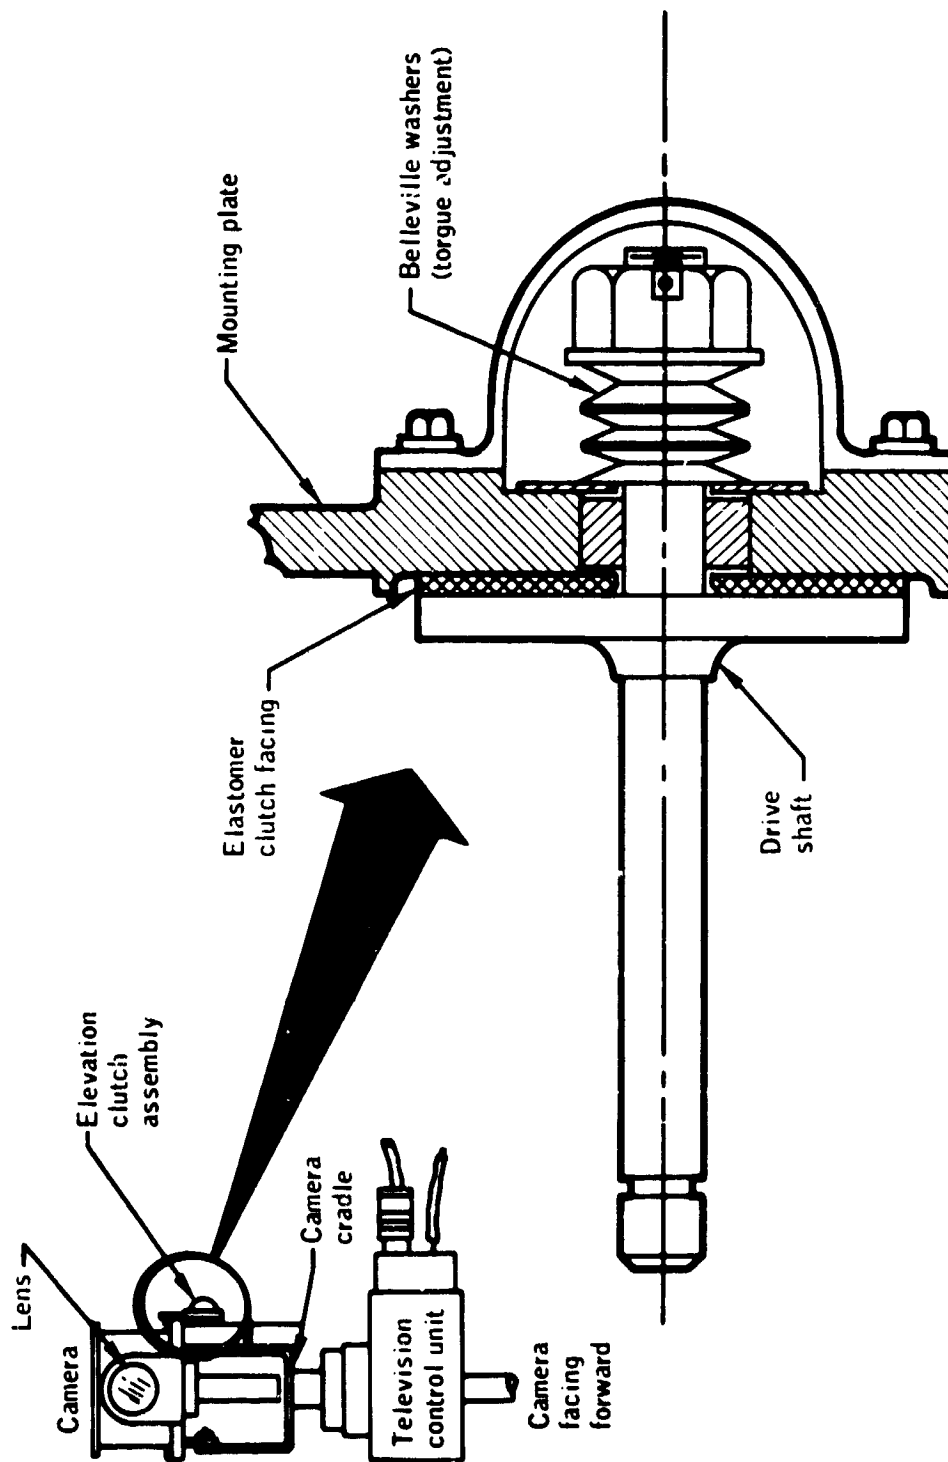
Figure 14-47.- Camera elevation control clutch.

During the second extravehicular activity, the camera could not be elevated as the unit approached the upper or lower limits of angular travel. The condition further deteriorated during the third extravehicular activity.

Elevation control is provided to the camera cradle through a friction clutch (fig. 14-47) which allows manual override of the ground-commanded camera positioning. The camera-cradle pivot point is approximately 3 inches below the center of gravity of the cradle with the camera mounted. As the camera moves away from the horizontal position, the unbalanced moment becomes progressively greater, and a higher torque load must be supported by the clutch mechanism.

The elastomer clutch-facing material provided the required stable friction properties in the specification and qualification test temperature range (122° F, maximum). However, the maximum temperature on the television control unit during the third extravehicular activity has been calculated as approximately 180° F. Materials specifications show that the compressive strength of the elastomer degrades rapidly at this temperature, and ground tests with flight unit 4 verify severely degraded performance with time at elevated temperature.
